Garrananaspick Ice House, Garrananaspick, Co. Waterford

CONSERVATION ASSESSMENT

June 2022

Job No. 21100

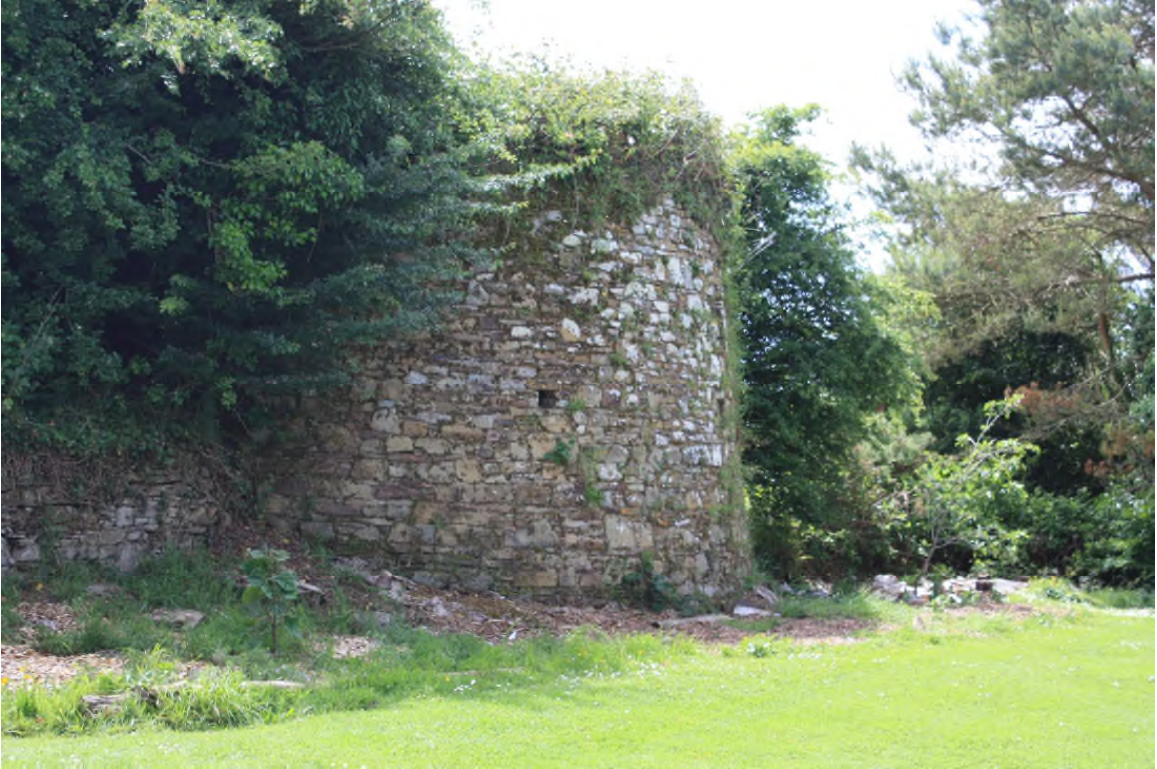
PHOTOGRAPH NO. 1

The "McKenna" Ice House at Garranaspick townland is unusual in that it is almost entirely above ground (Photo 1). Its near neighbour appears to have been mounded up while the other two surviving examples, at Ballynatray, are below ground and, what is known of the others, indicates that they were also below ground structures. It's somewhat later date of construction took advantage of advances in the understanding of insulation and the advantage of twin wall construction. The Ice House was built at a location where the rock is relatively close to the surface and where a quarry already existed. This provided a good foundation for the Ice House, as well as facilitating drainage from the bottom. It is fully cylindrical in shape standing 4m to 4.5m high, above ground, and is approximately 11.5m in diameter. The inner wall, measured at the door, is 800mm thick and the outer wall is 450mm to 500mm thick with an insulation gap of 300mm. The insulation infill is not known at this time, but it may have been compressed bracken, as the more desirable peat was generally unavailable in the locality. There is no evidence that it ever had a masonry dome, which would have been difficult to restrain in a freestanding structure. It is most likely, therefore, that it had a thatched roof.

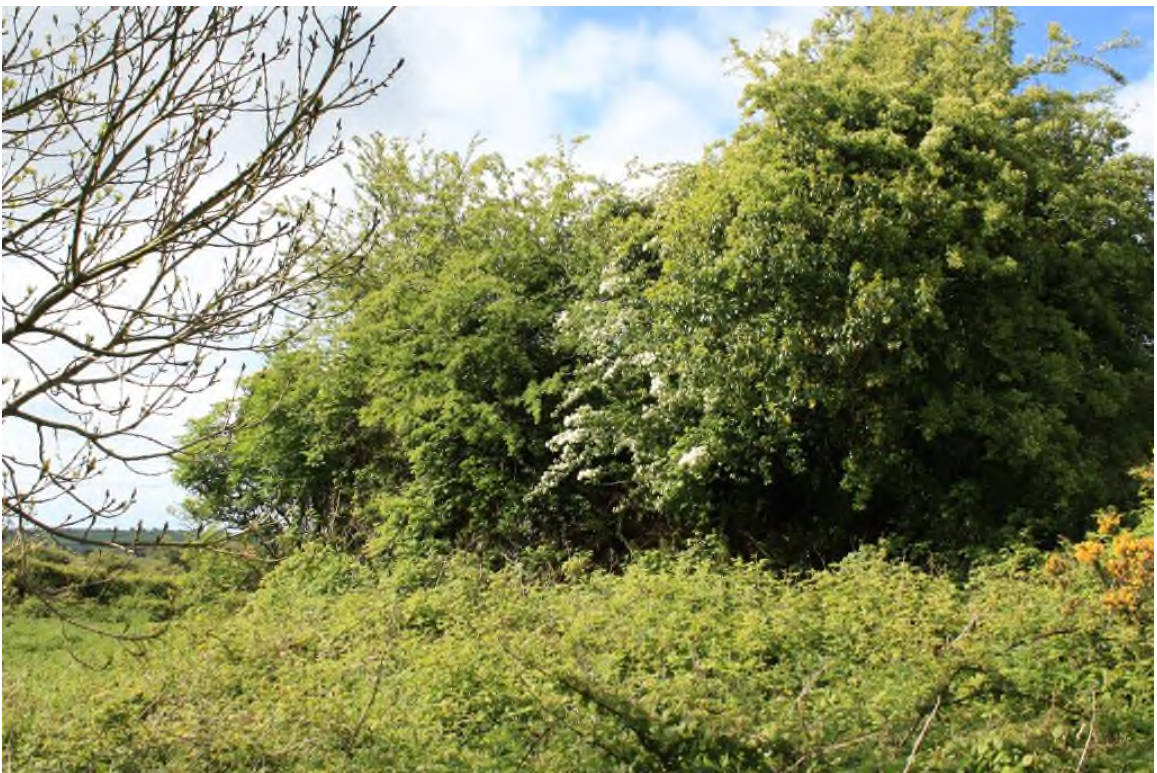
PHOTOGRAPH NO. 2

The “McKenna” Ice House was until recently completely obscured by scrub, briars and saplings growing in and around the base of the Ice House (Photo 2). The clearance of the vegetation not directly connected to the Ice House has permitted a better evaluation of its condition. The north side is almost clear of vegetation, except for the wall top (Photo 1), whereas the south and west sides have ivy and saplings growing (Photo 3) and the east side has trees (Photo 4).

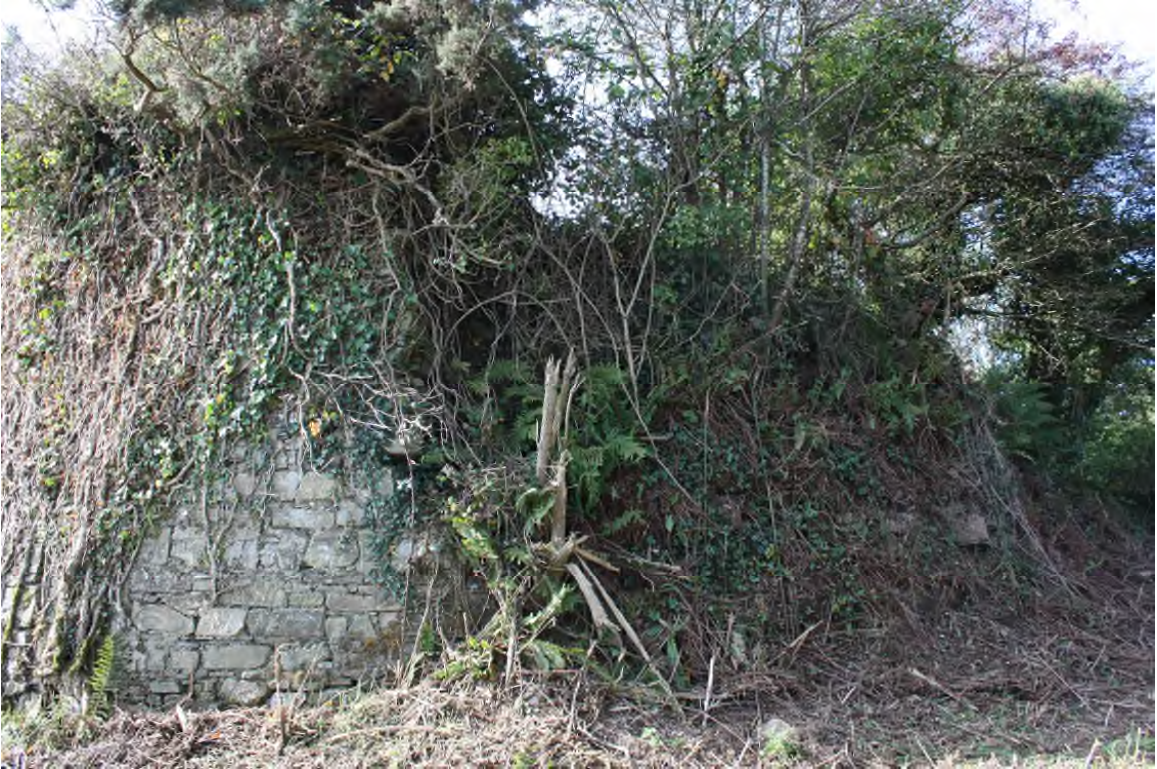
PHOTOGRAPH NO. 5

The visible external masonry is all in good condition around the perimeter with the exception of the site of the former entrance tunnel (Photos 5 & 6). A recent drone flight of the interior indicates that the masonry of the interior is generally in good condition.

The most damaged part of the structure is at the location of the former entrance passage or tunnel. It appears that the tunnel may have been mined for building stone in the past, which has resulted in the complete obliteration of all traces of it. The masonry from ground level up to entrance level is in a very loose condition at the entrance location (Photo 7). The external wall is missing on either side of the former entrance from approximately 1.5m above ground level and extending 4m to the north and 5m to the south. On the northern side of the external wall a small area of stone is missing but it is otherwise in good condition (Photo 8). On the southern side there are two cracks which run from the base to the top of the wall but, without loss of masonry (Photos 9 & 10). The condition of the wall tops cannot be determined at this time because of the growth of vegetation. There are trees growing close to, and possibly attached to, the east side at the former entrance ramp and there are saplings growing from the insulating fill between the two walls (Photos 11 & 12).

Consolidation of the wall tops will first involve the clearance of all accumulated humus from the wall top and from underneath any stones that have been disturbed by ivy wedging. The masonry may then be reset and flaunched with approved lime mortar. The broken wall ends will also need to be carefully raked out to remove all humus and dead mortar, followed by well packed mortar filling of the joints and weather pointing. The two cracks on the southern face of the external wall will need to be cleaned out and packed with lime mortar, the final finish of which should be recessed from the face. The small area of missing face work on the northern side will also need to be thoroughly cleaned out, pointed and flaunched.
